Example: Tanks and vessels

Application Note

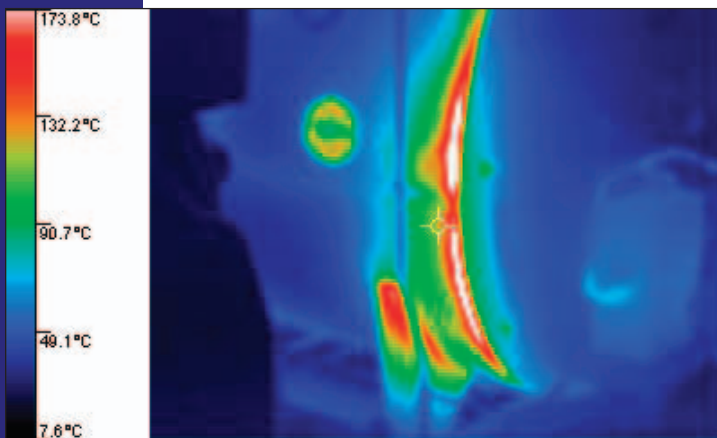
This tank may have leaks in the seams.

Other tank and vessel conditions that can be monitored using thermography include damaged refractory or liners and leaks in tank walls. Under the right conditions, a damaged refractory or liner will show up as hot or cool spots. Most leaks occur because of the failure of a seal or gasket, although sometimes corrosion will lead to a leak in a vessel's wall. Whatever its origin, a leak is likely to manifest itself as a temperature anomaly.

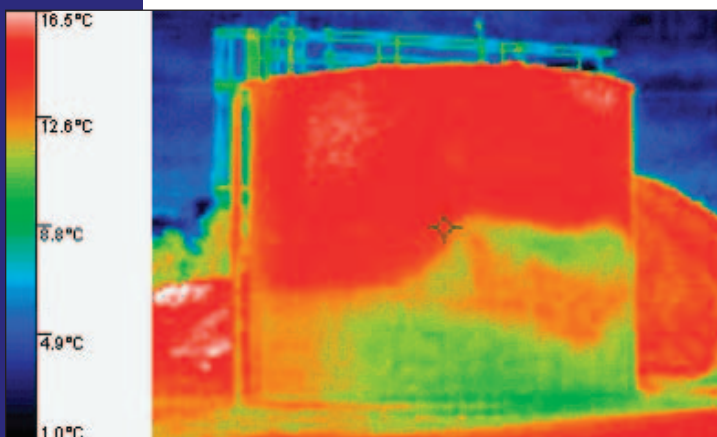
The temperature differentiation in this image probably indicates the transition between substances (a gas and a liquid) as well as some potentially uneven settling.

A thermal image of a tank that is completely empty or completely full, or that has a shiny reflective skin, will appear uniform and no product level will be apparent. Otherwise, the product level will appear as an obvious thermal separation between the headspace and the product.
